SUBJECT: Pepper's Steel Site
Five Year Review

SITE SKETCH
PEPPER'S STEEL AND ALLOY SITE

Final Report
Pepper's Steel Site
Section: 1
Revision: 2
Date: April 1994

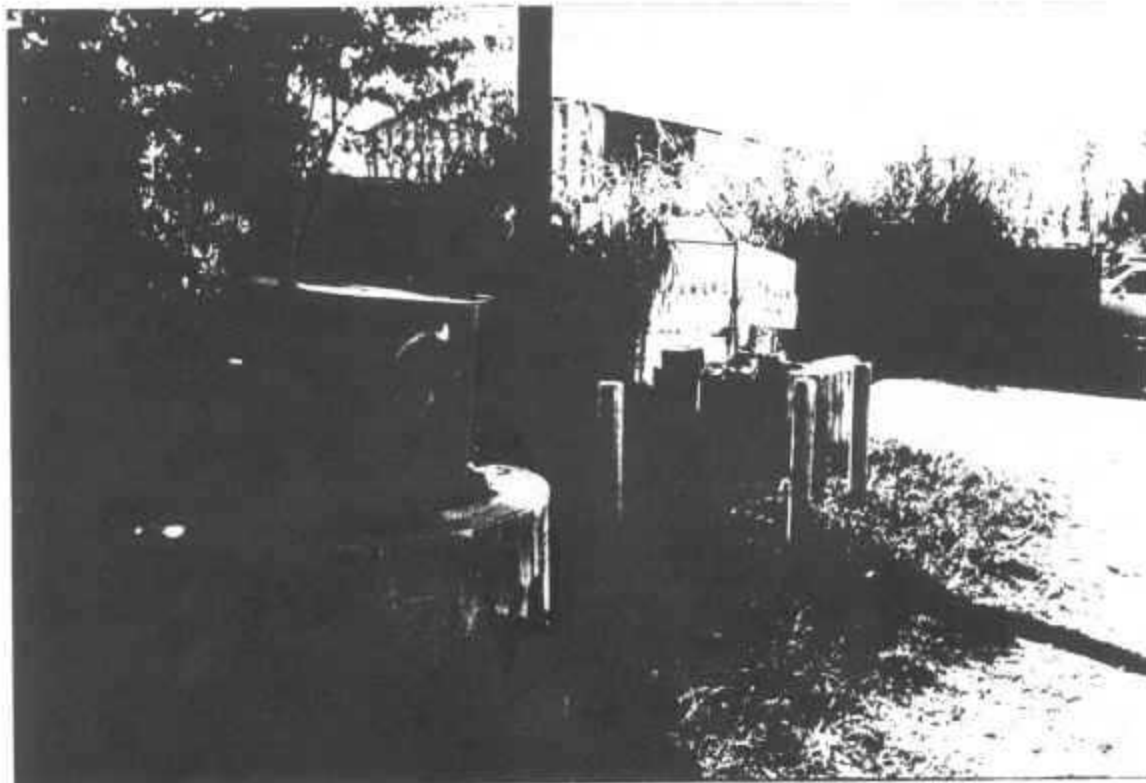
Photograph No. 2

Description: Groundwater sampling of monitoring wells 6A and 6B.

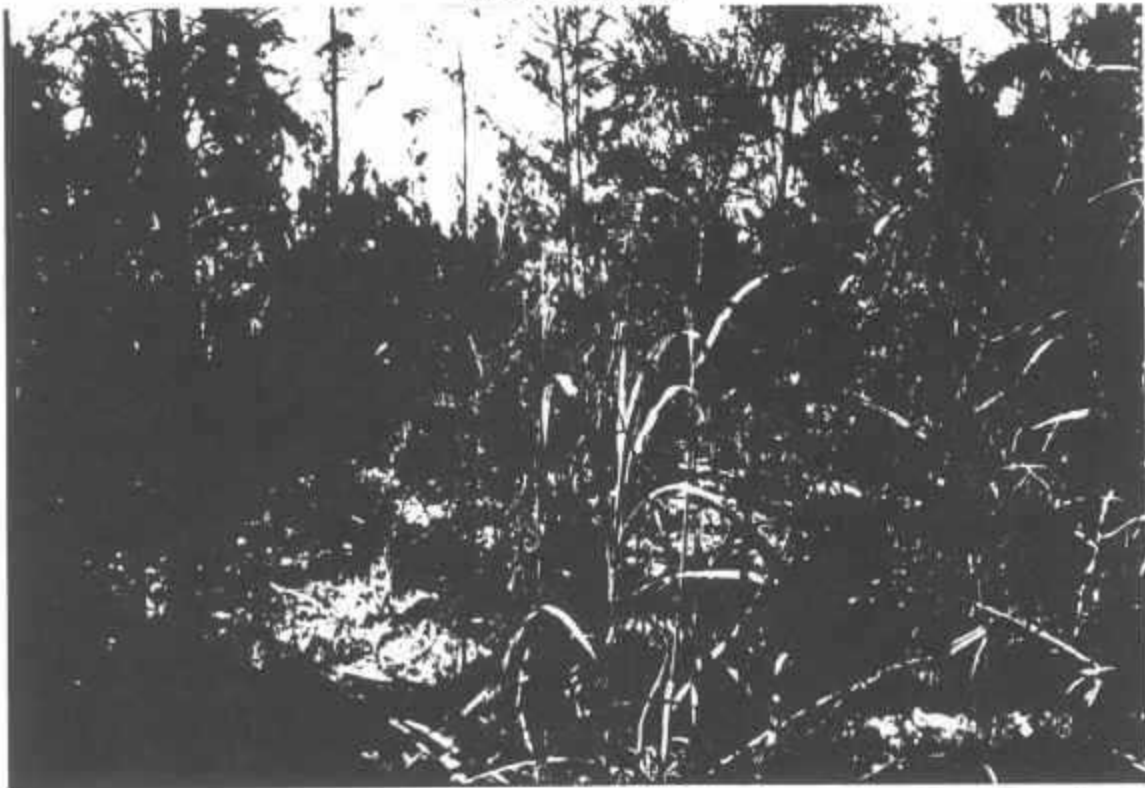
The following is a summary of WESTON's observations made during the site tour with references to photographs which are included as Appendix B of this report. Photograph No. 3 is a typical view of the surface conditions. It is heavily vegetated with grass, Florida Holly, and Australian pine trees. The dense vegetation made it difficult and even impossible to perform observations of the monolith structure.

Description: Typical view of the surface monolith cover.

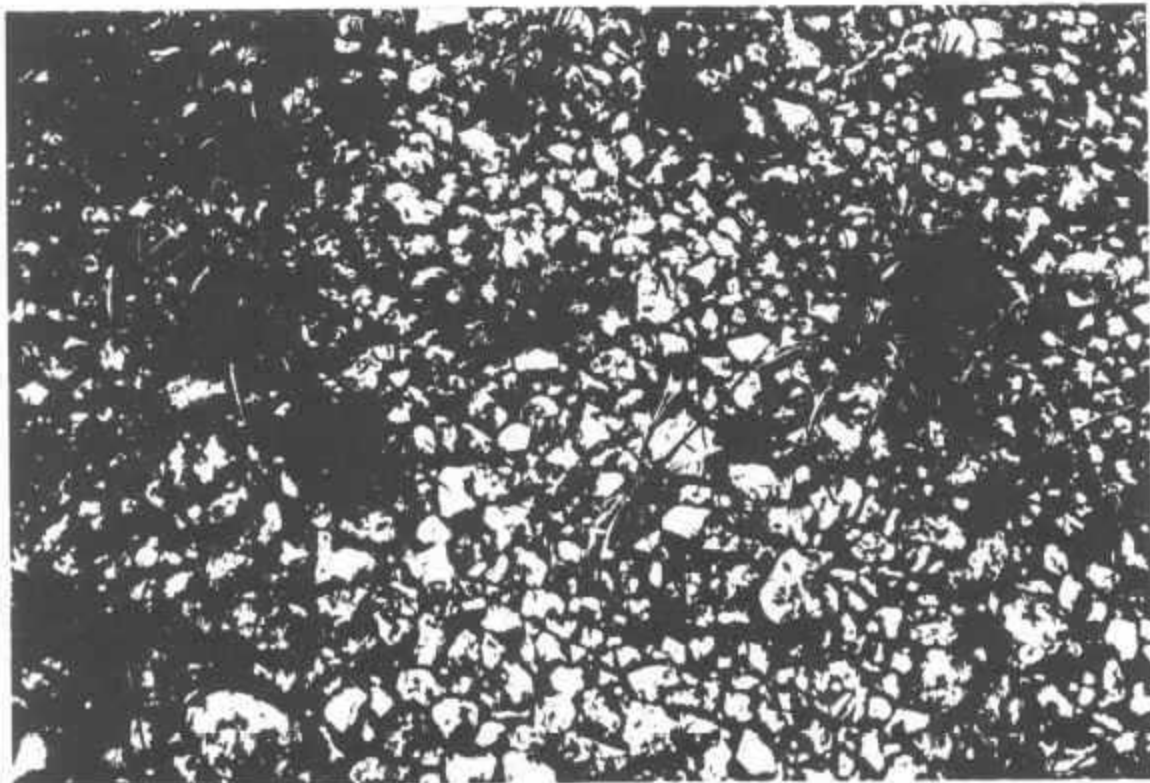
Photograph No. 4

Some open areas were observed with the crushed limestone surface clearly visible (Photograph No. 4). This cover was designed to protect the underlying monolith from wind and surface water erosion and to neutralize acid rain. The rock surface appears to be functioning well in the area. It was impossible to make an assessment of the crown and slope of the surface due

Description: Close-up of the limestone rock cover on the monolith.

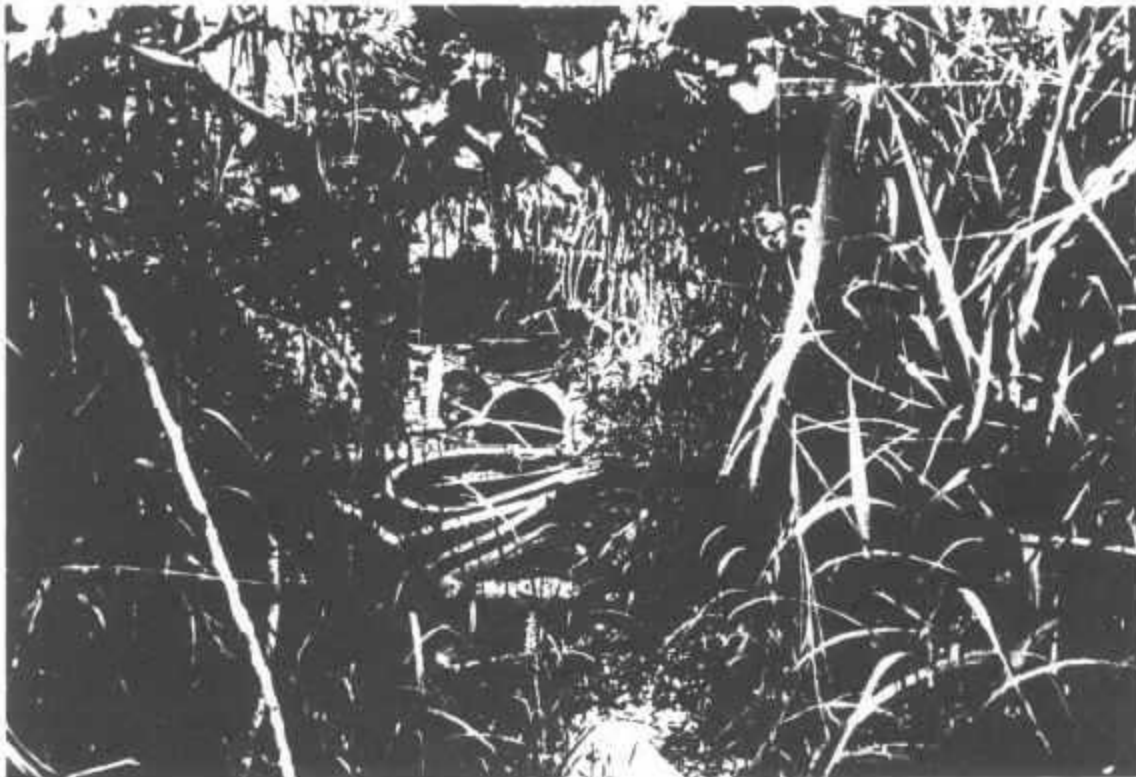
Photograph No. 5

The inspection plan was to follow the perimeter fence line to observe the condition of the fence and drainage collar. A large hole was observed in the northwest section of the fence (Photograph No. 5). A path on both sides of the fence indicated regular pedestrian traffic onto the site. Photograph No. 6 is a typical view of the drainage collar. Most sections appeared to be in good condition and functioning as intended. Unfortunately, approximately 50 percent of the fence line and drainage collar was not visible. Photograph No. 8 shows the high grass preventing access for observation purposes.

Description: Hole in the northwest section of the chain link fence. Path leading to local trucking company.

Although the fence is not required under the Consent Decree, consideration should be given to the potential hazards to those entering the property. Specifically, those associated with the abandoned Jim Woods building contain unknown drums and compressed gas cylinders.

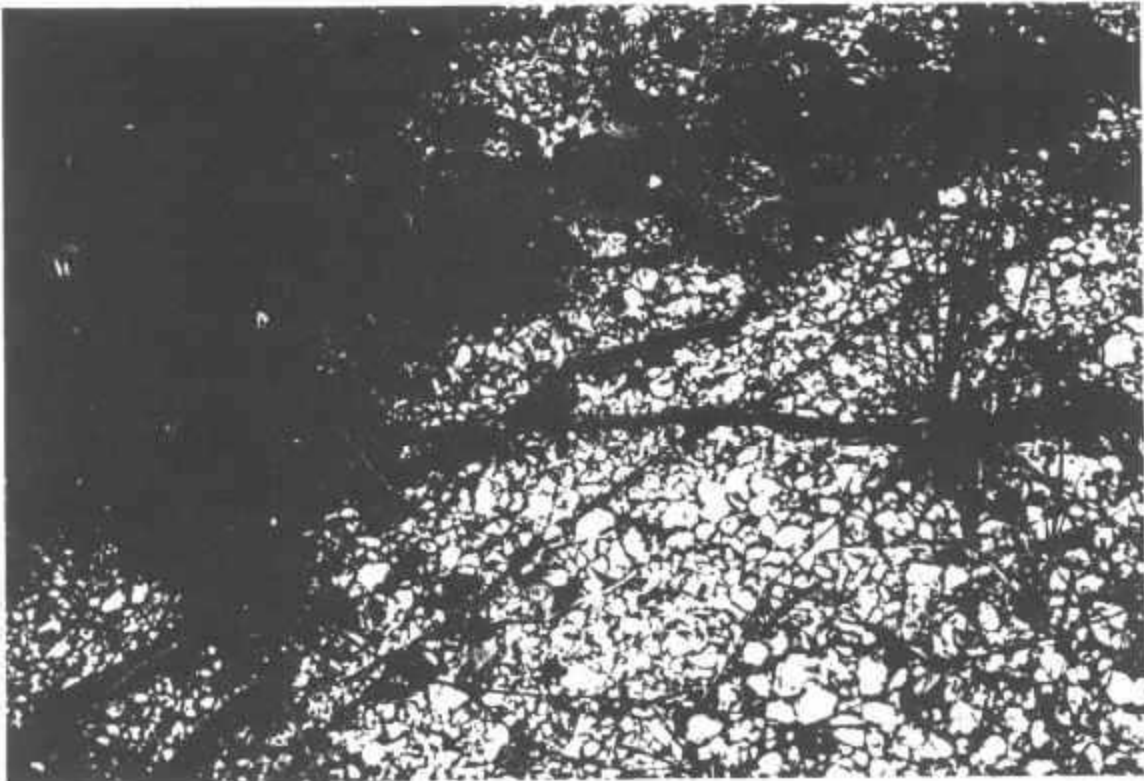
Photograph No. 7

monolith were of concern to EPA. WESTON's Paul Durr performed a vegetation survey on May 12-13, 1993. A complete report of this assessment is included as Appendix D. In general, WESTON found that the current root systems of the trees do extend through the limestone cover and then proceed horizontally along the hardened surface of the monolith. Further observations are that fissures most likely will develop in the monolith due to differential settling and normal expansion and contraction. These fissures most likely will be invaded by root systems exacerbating the natural fissuring process. This will in effect increase the surface area exposed to weathering.

Description: Vegetation and root systems growing on the monolith cover.

Although there appear to be no immediate vegetation related threats to the Pepper Steel monolith, plant root invasion will only serve to exacerbate natural fissuring processes. While complete woody vegetation removal is not warranted at this time, it would be prudent to institute procedures to monitor the integrity of the monolith on a periodic basis. Personnel involved in such activities should include engineers familiar with the affect of increased surface area exposure and weathering on the potential release of contaminants from pozzolanic grout matrices.

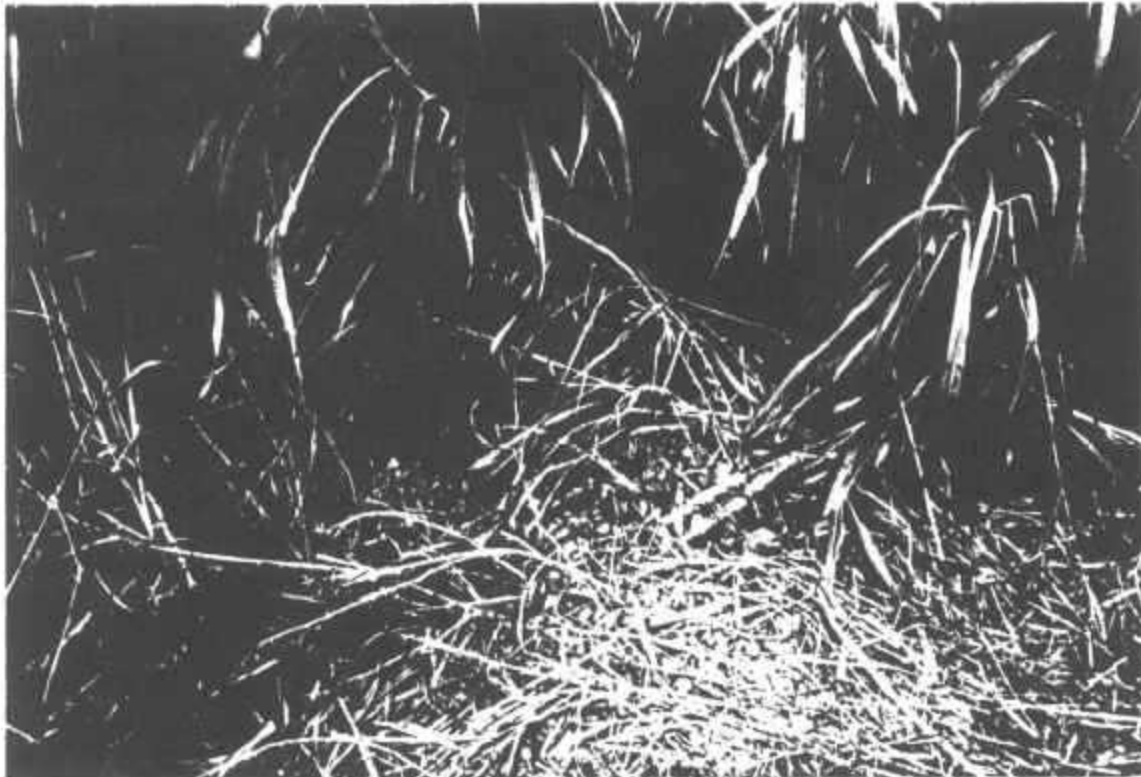
Photograph No. 9

Description: Drainage collar covered with grass.

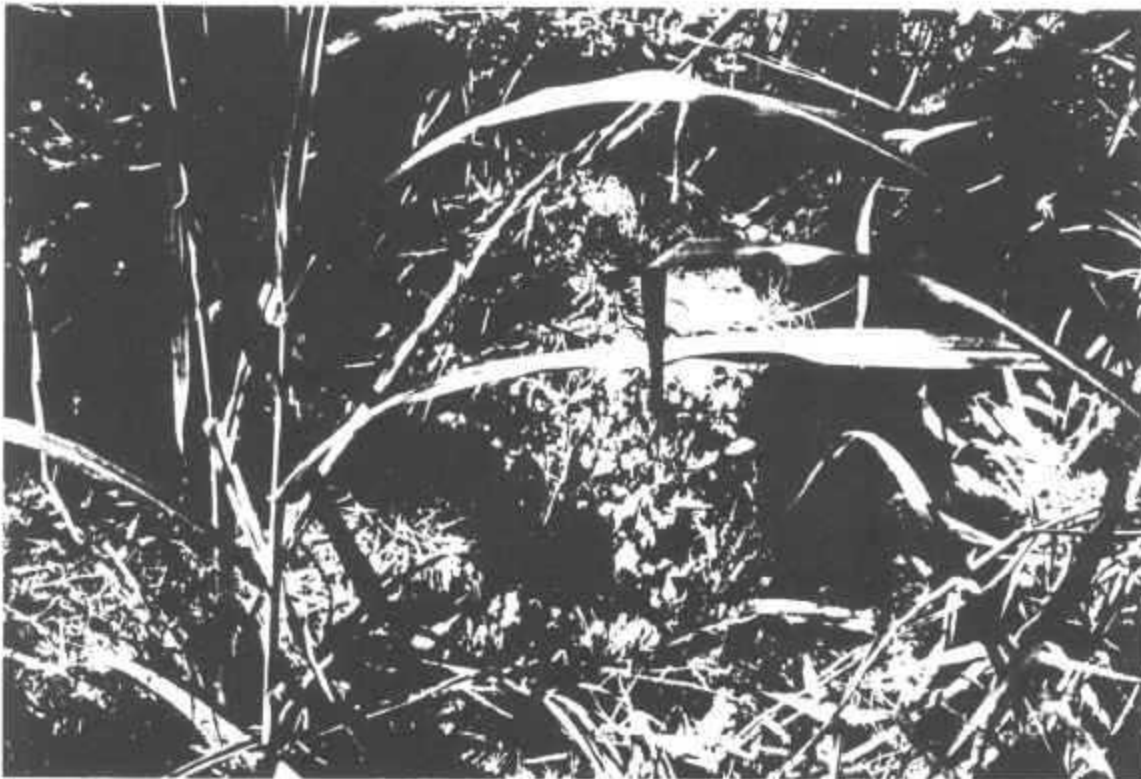
Photograph No. 10

Description: Tree pushed over by high winds exposing shallow root system.

At the current time it does not appear that the integrity of the cement/pozzolanic monolith is threatened by the encroachment of woody and herbaceous vegetation. Australian-pine, the species of primary concern, is a very shallow rooted tree that is unlikely capable of causing short-term physical damage to an intact structure that is reported to have a penetration resistance of at least 500 psi. Direct observations made by the WESTON botanist indicate the roots associated with the largest trees fully occupy the crushed limestone layer beneath but then move horizontally taking the path of least resistance across the upper surface of the hardened monolith.

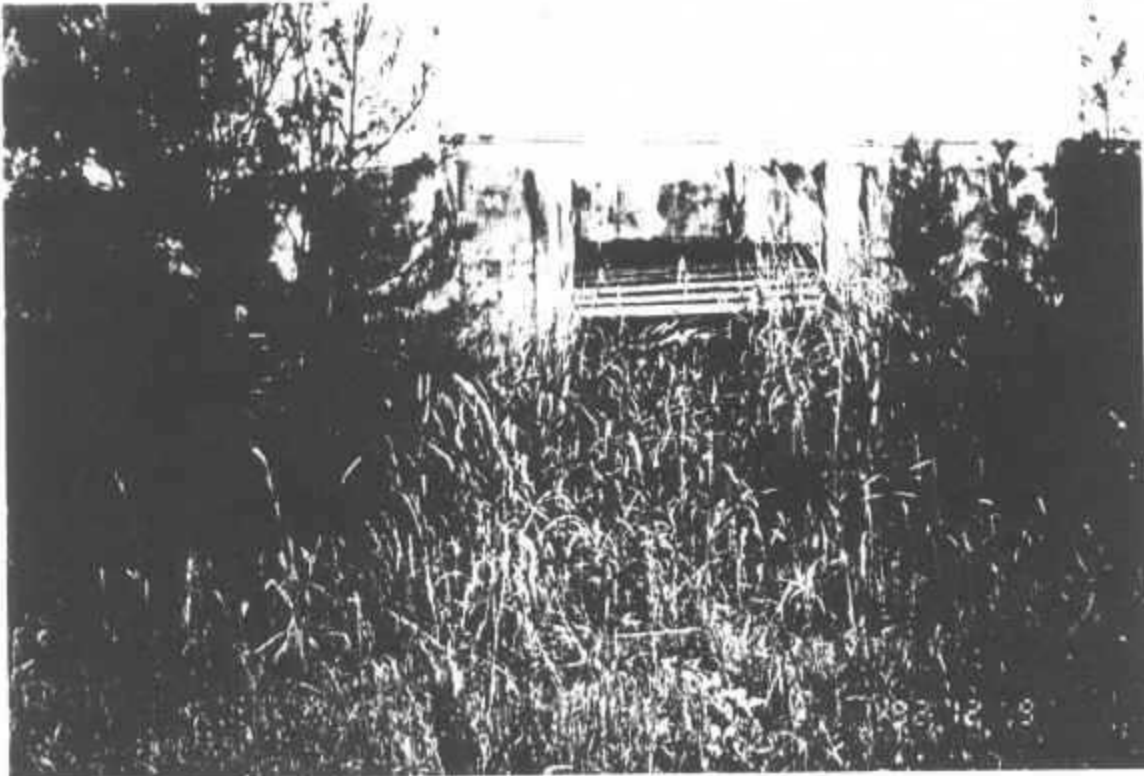
Photograph No. 11

We then proceeded to the southeast side of the monolith to observe the abandoned Jim Woods Building (Photograph No. 11, see Figure 1-2). Inside the building many old engine and truck parts were observed (Photograph No. 12). Unlabelled drums containing liquids (Photograph No. 13) and compressed gas cylinders (Photograph No. 14) were observed strewn about inside the building. Due to holes in the perimeter fence, this building is accessible and the contents could pose a potential hazard to human health.

Description: Abandoned Jim Woods building located on the southeast side of the monolith.

The status of the Jim Woods building requires immediate attention. It is a direct contact threat as long as access is not restricted. The miscellaneous equipment and parts are valuable to nearby businesses as well as curious observers. Any individuals rummaging around the building could push over the drums or accidentally damage the unprotected valves of the compressed gas cylinders. Either one of these scenarios could create a release of unknown, potentially hazardous materials. There are threats which may meet the criteria for initiating a removal action as specified in Section 300.415 of the NCP or at least a removal site evaluation under section 300.410.

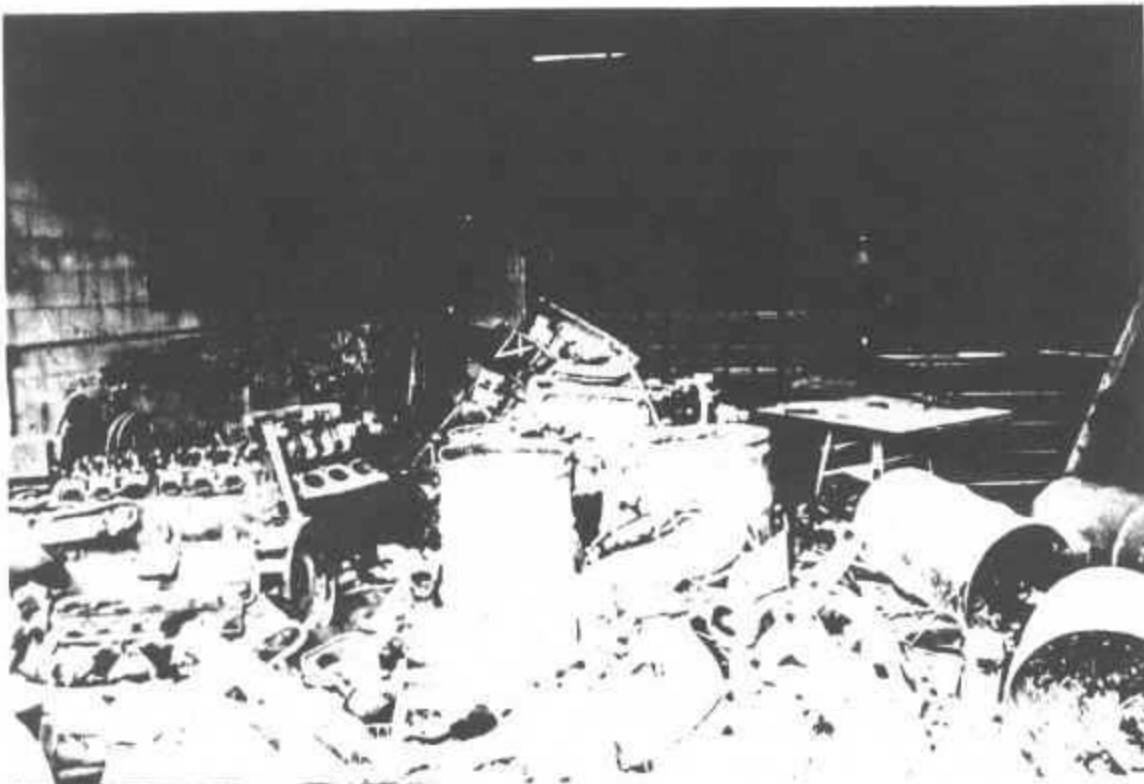
Photograph No. 12

Description: Inside Jim Woods building showing old truck and engine parts.

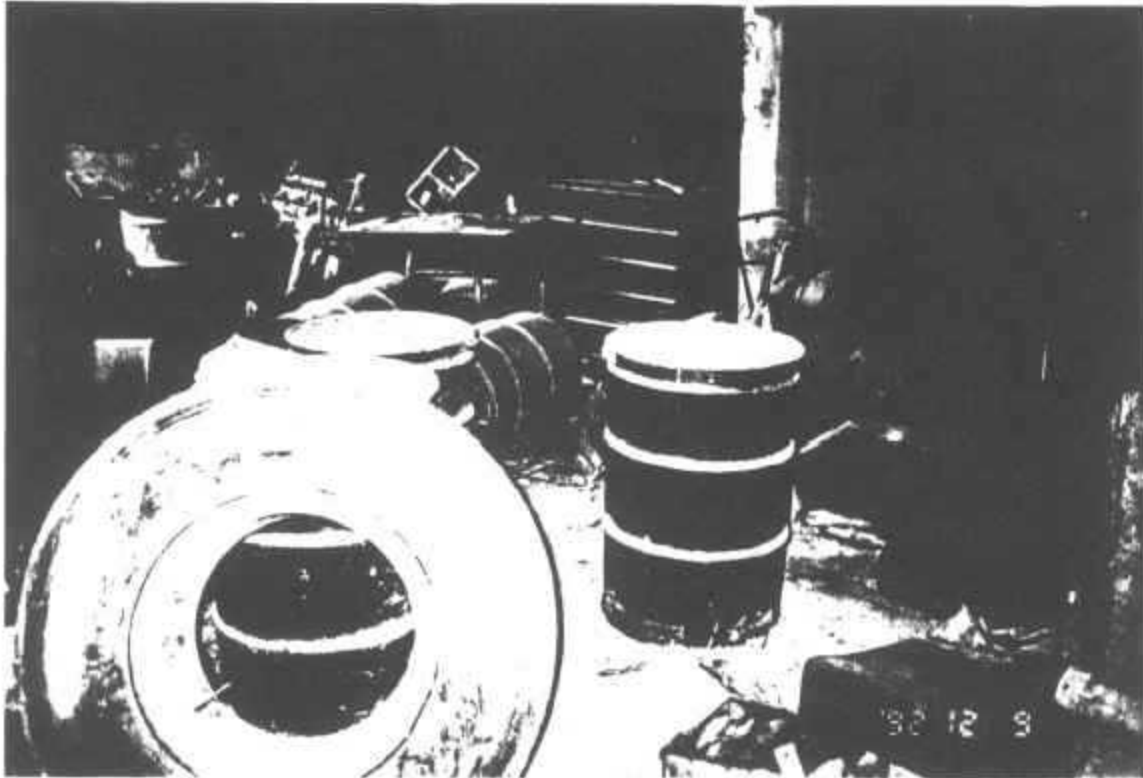
Photograph No. 13

Description: Inside Jim Woods building showing unlabelled 55-gallon drums containing liquids.
